Two Fire Fighters Die and Two Are Injured in Townhouse Fire—District of Columbia

Fatality Assessment and Control Evaluation Investigative Report #99F-21

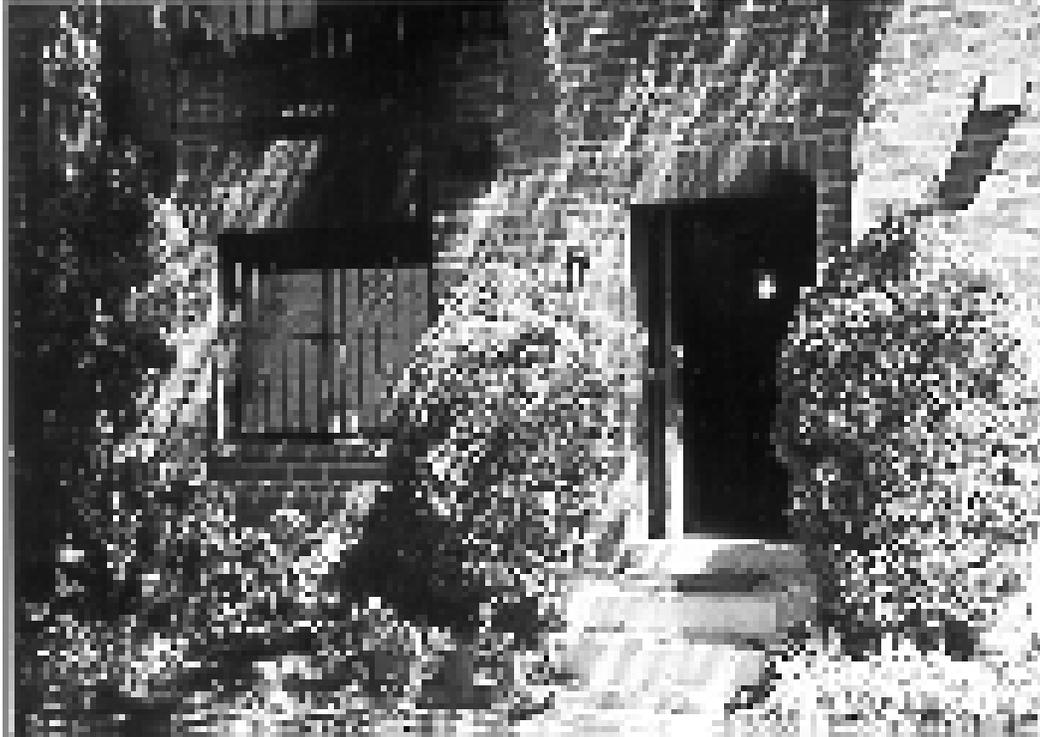
Photo 1: This photo depicts the front (side 1) entrance of the townhouse involved in the incident.

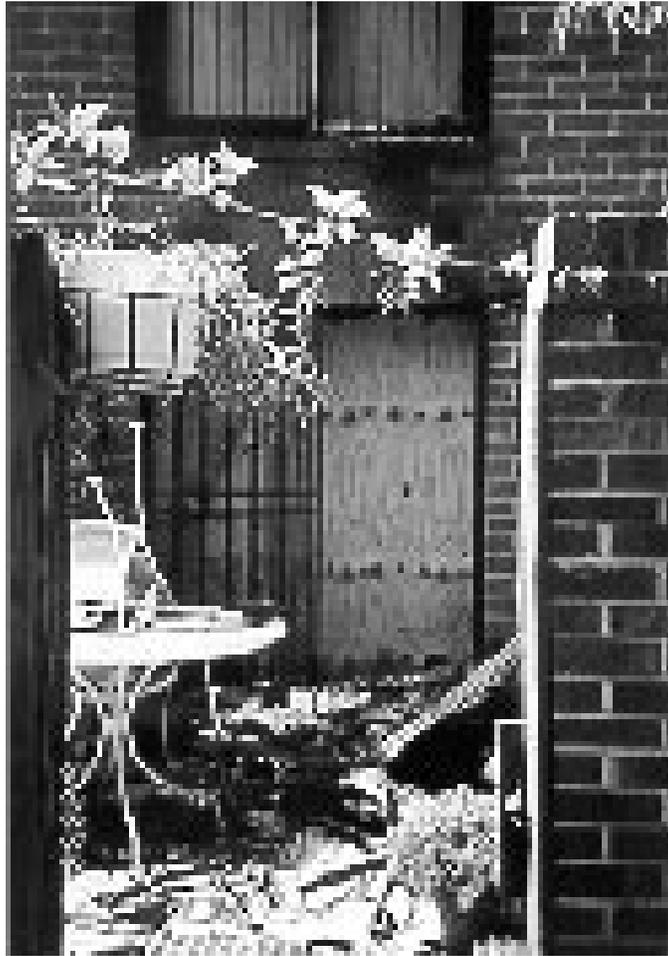
hammer, the officer and fire fighter from Truck 4 removed the iron security gate and broke open the glass door at 0026 hours (see Photo 2). Members of Truck 4 and Engine 17 stated that when the sliding-glass door was opened, air began to be sucked inside by the fire. They also saw small fires on the floor and stated that when the door was opened the fires grew larger. The Lieutenant from Engine 17 reported to the IC that they had fire on the first floor and requested permission to hit the fire. *[NOTE: Engine 17 was unaware that they were at the basement level due to the route they took to get to the rear. As they proceeded to the rear, they noticed the row houses they went between were only two stories, which caused confusion (see Diagram 1).]* The IC denied their request in fear of opposing hose lines. He then radioed the officer from Engine 26 to locate their position. He received no response from them. The IC knew that the crews from Engine 26 and Engine 10 had entered through the front door on the first floor.

Photo 2: This photo depicts the rear (side 3) sliding-glass door leading to the basement
